# CAMBRIDGE NORTH

## ARBORICULTURAL IMPACT ASSESSMENT

**Tree Survey, Arboricultural Impact Assessment  
Preliminary Arboricultural Method Statement & Tree Protection Plan  
In Accordance with BS 5837:2012**

Proj. No <b>9251</b>	<b>Chesterton Sidings, Cowley Road, Cambridge</b>		
Client:		Brookgate	
Date of Report:	13/05/2022	Revision:	Original

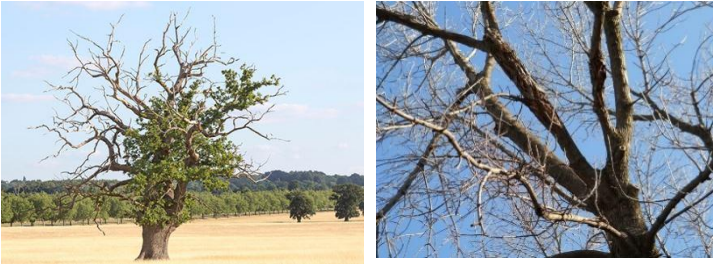
<b>Name: Deadwood</b>	
<b>Symptoms/damage type and cause:</b>	This relates to dead branches in the crown of the tree. In the majority of cases, this is caused by the natural ageing process of the tree or shading due to its close proximity to neighbouring trees. However, in some situations, it may be related to fungal, bacterial or viral infection.
<b>Consequence:</b>	Depending upon the location and mass of dead wood removal of the affected tissue may be necessary to prevent harm to persons or property as the wood will become unstable as it decays and in some circumstances is likely to fall from the tree with little or no warning.
<b>Control:</b>	Detailed monitoring should be undertaken on those trees showing signs of excessive deadwood production to identify the underlying cause.
<b>Species affected:</b>	Most tree species.
<b>Images:</b>

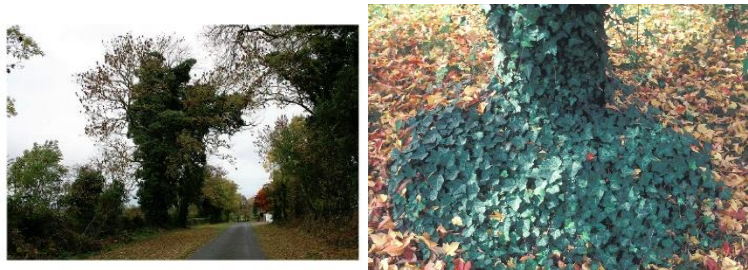
<b>Name: <i>Hedera helix</i> (Ivy)</b>	
<b>Symptoms/damage type and cause:</b>	Ivy may grow to varying degrees on all areas of a tree from the base to the upper crown. It is possible that in doing so it will out-compete the host tree for available light thereby suppressing the host.
<b>Consequence:</b>	This is generally only harmful to the tree on already unhealthy specimens which may be constricted by large ivy stems around the trunk or may have their top growth suppressed by a mass of flowering shoots in the crown. Ivy can also mask potentially dangerous faults on a tree.
<b>Control:</b>	Ivy should only be removed if absolutely necessary because it provides abundant cover to wildlife and then by severing twice close to the ground and removing a length of stem thereby causing the gradual dying away of the aerial parts of the plant providing extended benefit to wildlife whilst relieving the pressure on the tree.

<b>Species affected:</b>	Most trees can be affected.
<b>Images:</b>
